**Aircraft Operator Information:**

**Aircraft type:** C208  
**Time:** 750,6 Hrs.\*

**Aircraft SN:** 20800372    **Aircraft Total**

**Location (City, State, Country):** Manaus, AM, Brazil

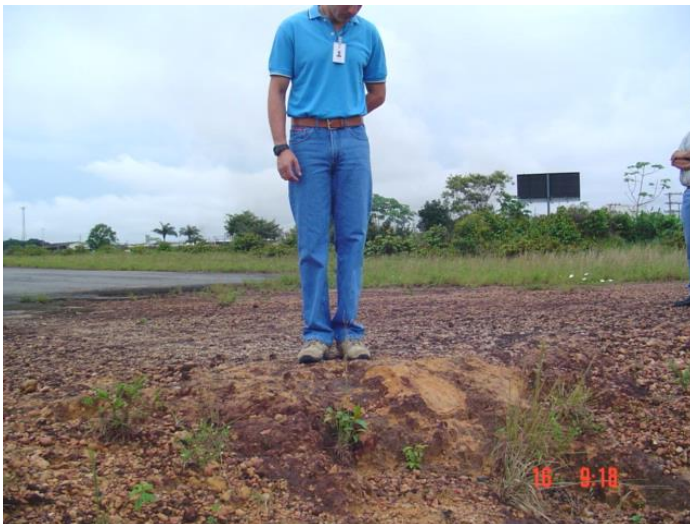
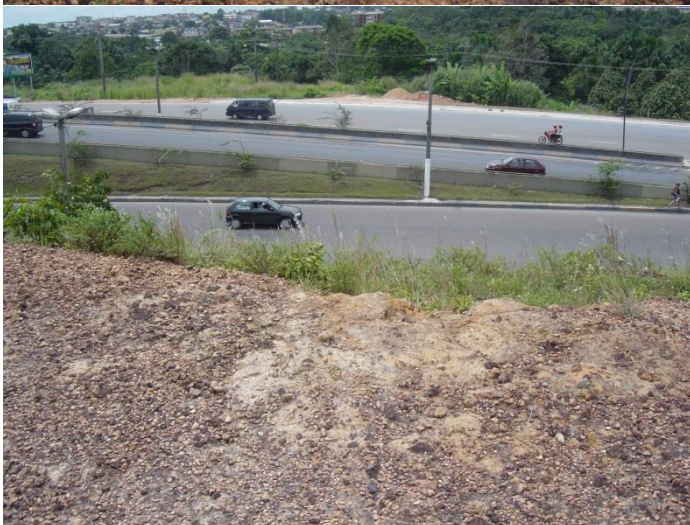
During a normal landing of the Aircraft in Manaus (SWFN) the aircraft hit the ground 10 yards before the runway with it's right wheel (see picture below).

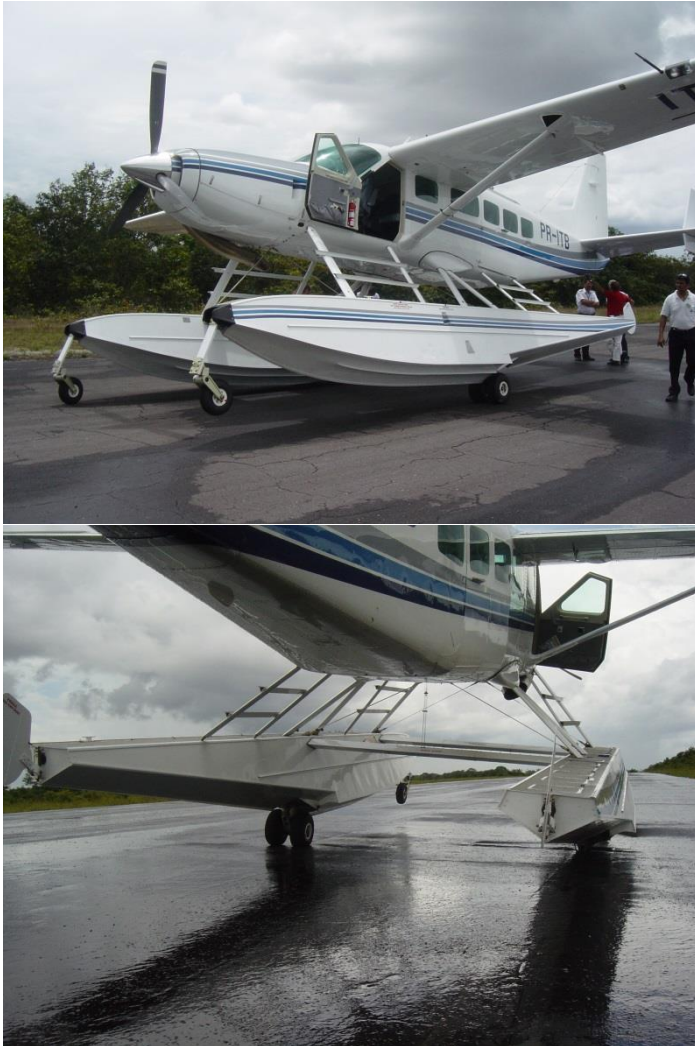
It was verified that during the hard landing the right landing gear was damaged.
